Property Condition Assessment (PCA) of

[REDACTED] Church

Table of Contents

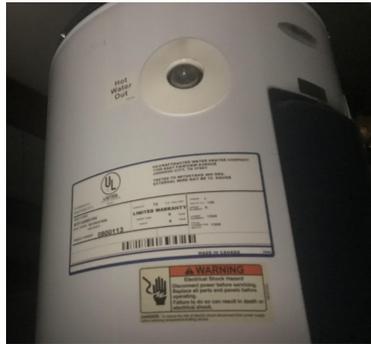
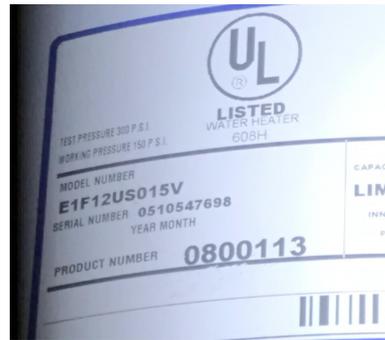
7.8 Hot Water Production: One 12-gallon, electric water heater provides hot water to the Congregation Hall and is 14 years old. One, 40-gallon, electric water heater provides hot water to the Commons building and is 18 years old. Replacement Reserves are anticipated within the term.

- Condition: Good

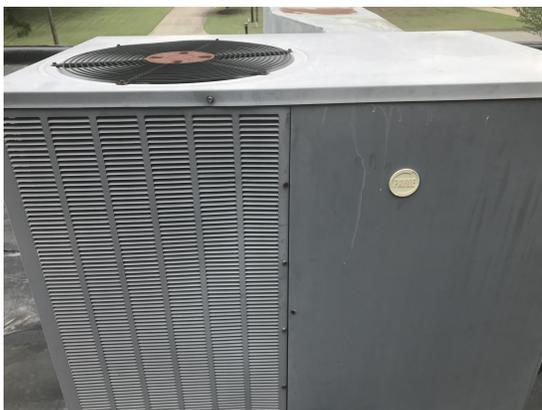
8.1 System Overview: One Payne, Roof Top-mounted Unit (RTU) heat pump provides heat and cooling for The Commons building. This unit appears to be 4.5 - 5 Tons cooling capacity and is 11 years old (2011).

MODEL		PH3ZNB060000AATP									
N° DU MODELE		1811X94974									
SERIAL / SERIE		1811X94974									
FACTORY CHARGED WITH R-410A REFRIGERANT											
253	MAX	197	MIN								
PH	HZ	RLA	LRA	FACTORY CHARGED		TEST PRESSURE GA					
1	60	26.4	134	LBS	KG	HI	450	PSI	3102

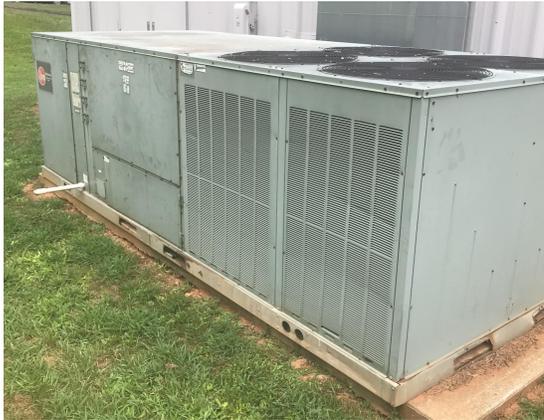
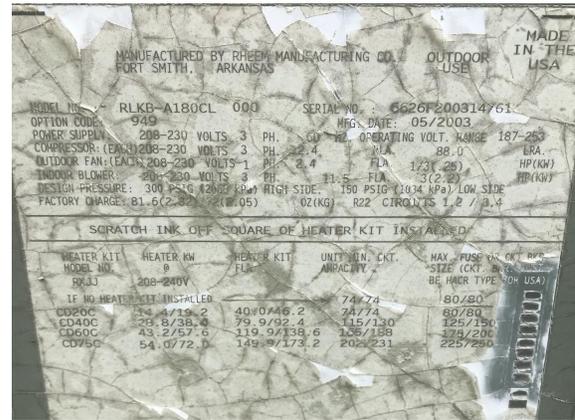
The Congregation Hall has two, Rheem 15 ton air conditioners, approximately 19 years old (2003). The Congregation Hall has a Reznor, ceiling-mounted, propane-fired heating element with 300K BTU capacity.

- Condition: Fair. The Payne A/C unit has a EUL of 15-20 years and replacement should be considered during the term.
- Condition: Fair. The Rheem units have a EUL of 20-25 years and replacement should be considered during the term.
- Condition: Good. The three units that heat/cool the classrooms/offices in the Congregation hall are approximately 10-12 years old. The Payne unit is a 5 ton A/C unit with heat pump. The two Carrier units are 3 ton capacity heat pump units. Units of this size and type have an EUL of 15-20 years depending on the location, maintenance and use and replacement should be considered during the term.
- Comment: One propane tank is located on the NE side of the Congregation Hall and supplies the ceiling-mounted heater.

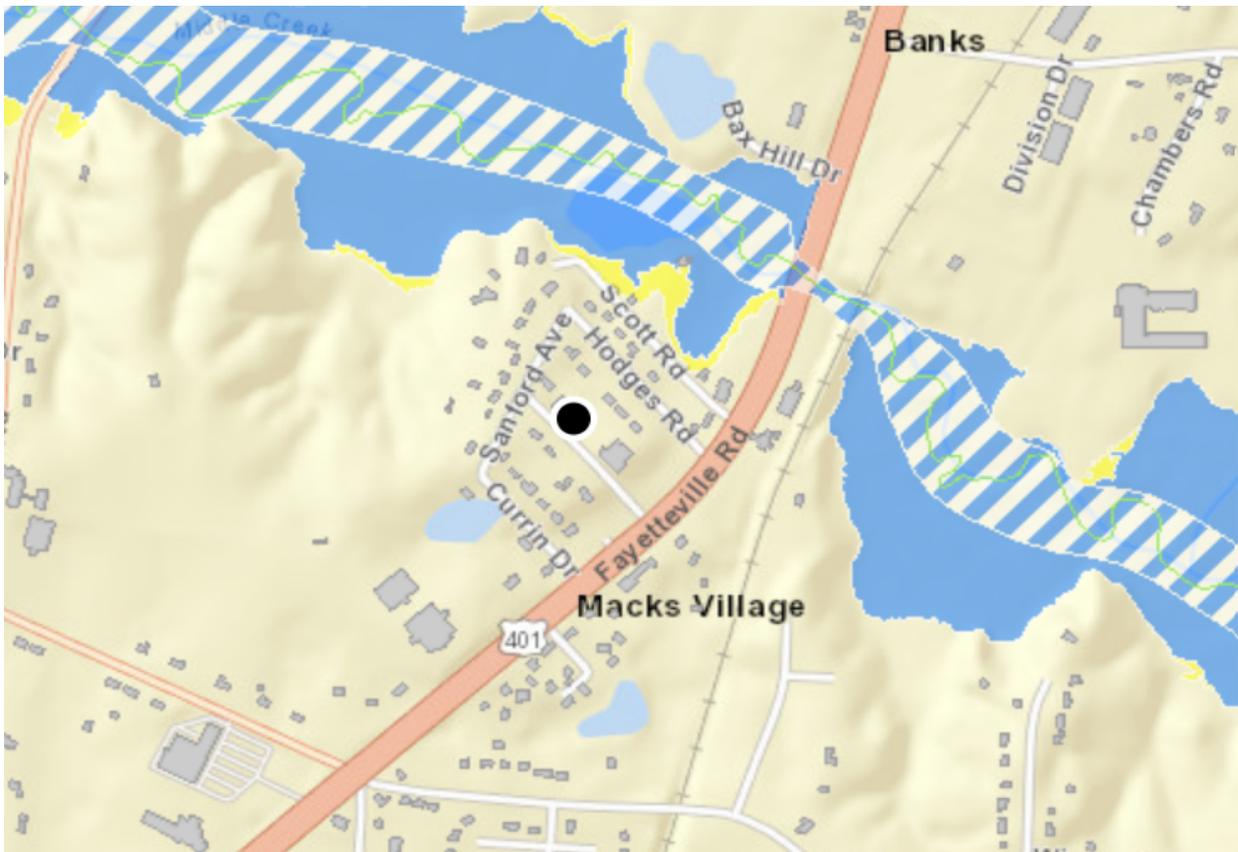
Appendix 3 - FEMA Floodplain Map

According to NC Floodmaps, this property does not lie in a floodplain.
