Property Condition Assessment (PCA) of

[REDACTED] Church

Table of Contents

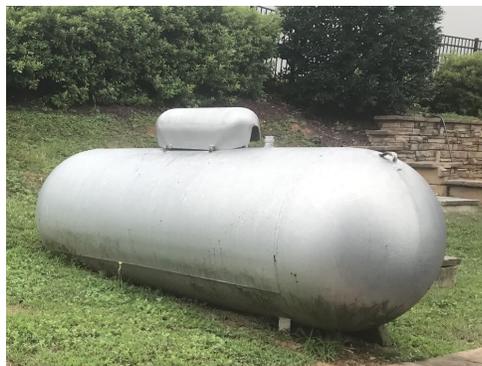
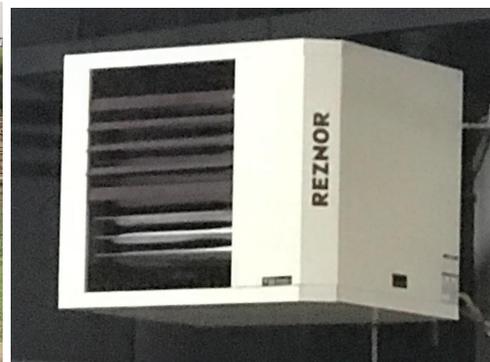
- Condition: Fair. The Payne A/C unit has a EUL of 15-20 years and replacement should be considered during the term.
- Condition: Fair. The Rheem units have a EUL of 20-25 years and replacement should be considered during the term.
- Condition: Good. The three units that heat/cool the classrooms/offices in the Congregation hall are approximately 10-12 years old. The Payne unit is a 5 ton A/C unit with heat pump. The two Carrier units are 3 ton capacity heat pump units. Units of this size and type have an EUL of 15-20 years depending on the location, maintenance and use and replacement should be considered during the term.
- Comment: One propane tank is located on the NE side of the Congregation Hall and supplies the ceiling-mounted heater.
